VIBRATION DIAGNOSTICS OF ANTIFRICTION BEARING DAMAGES DURING INSTALLATION AND ASSEMBLY OF HEAVY ROTORS

V.M. Shabaev, A.S. Kazantsev (JSC "Gasturboservice", Tyumen)
 M.K. Leontiev, I.V. Garanin (Moscow Aeronautical Institute, Moscow)
 V.A. Karasev (Central Institute of Aviation Motors (CIAM), Moscow)

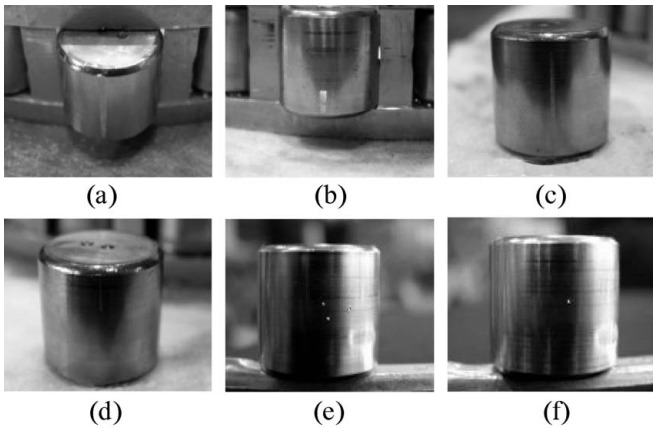
Fig. 2. Damages of rollers according to the measurement data.

Experiments were performed on the same new good state bearing. In this bearing, a new roller was replaced with a damaged one. Damaged rollers were taken from an exploited bearing. All of them were worn on the edges. These rollers were also additionally damaged analogously to what can happen in the process of installation. Images of such damages and their description according to the measurement data before and after testing are presented in Fig. 2.

(a) Flattened surface along the whole length of the roller; 0.015...0.025 mm in depth. (b) Small flattened area on the part of roller length; 0.018 mm in depth, 4.5 mm in length. (c) Groove along the whole length of the roller; 0.046 mm in depth, 0.64 mm in width. (d) Small groove on the part of roller length; 0.023 mm in depth, 5 mm in length, 0.3...0.5 mm in width; buckling of material at the edge of a groove before testing 0.063 mm, after testing 0.018 mm. (e) Three sharp dents + one sharp dent; 0.3...0.5 mm in diameter; 0.064 mm in depth; material buckling near the sharp dent – 0.006 mm; single sharp dent is placed circumferentially at the angle of 215° relatively to the zone of three sharp dents. (f) Single sharp dent; 0.5 mm in diameter; 0.053 mm in depth

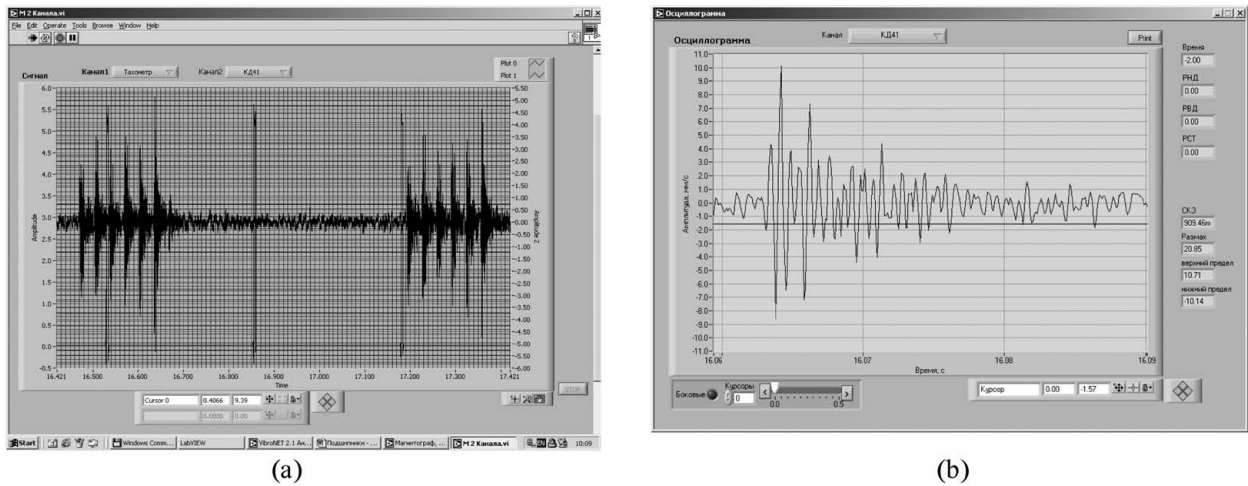
Fig. 5. Oscillogram of a signal from the bearing with damaged flattened surface along the whole length of the roller. Regime 1. (a) Interval between index marks of rotation frequency sensor is equal to one rotor turn. (b) Stretched oscillogram of an impact response signal

Flattened surface along the whole length of a roller (Fig. 5). As it was expected, the signal created by a bearing damage represents periodic sequence of a set of several impulses. Maximal signal amplitudes reached (0.4...0.8)g at regime 1 and (1.0...1.8)g at regime 2. An interval between neighbor impulses equals 1/2BFS; the cycle of set repeating is equal to one turn of a cage-carrier, i.e. 1/FTF; number of impulses in the set – 6 (sometimes 7).

In the interval between impulses there are detected several (12...15) damped oscillations with the frequency around 1000 Hz, what can be clearly viewed on a stretched oscillogram (Fig. 4, (b)). These oscillations are totally attenuated till the next impulse. This is characteristic for a dynamic system’s response to impact under condition of comparatively low damping, when duration of an impact is considerably shorter, than that of oscillation period of the very system, and an impact frequency is low.

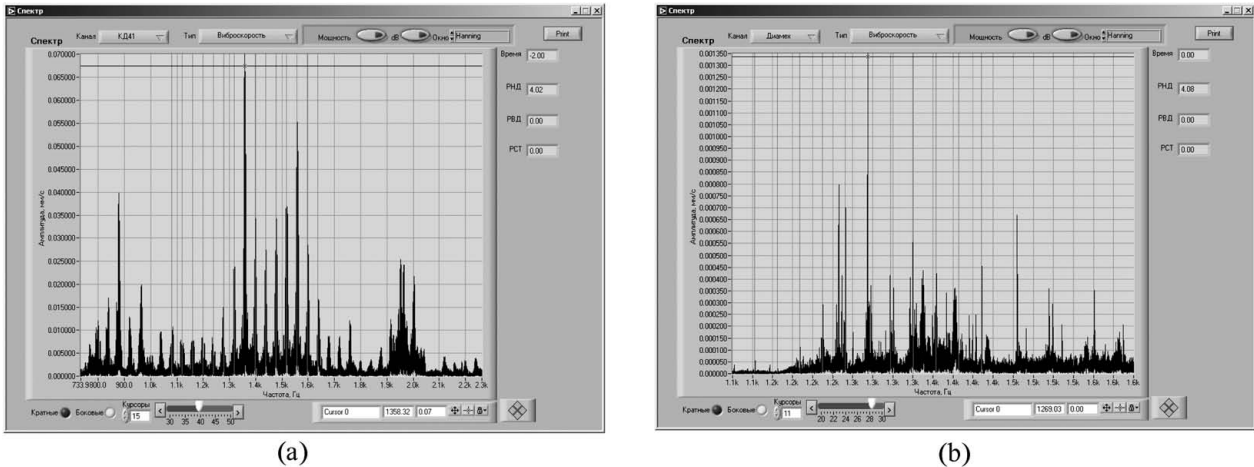
Fig. 6. Spectral recording of vibration velocity. Regime 2. Side harmonic components with following steps. (a) ~ 39 Hz (2BSF). (b) 28 Hz

Fig. 6 (a) shows a spectrogram of a vibration signal from the bearing with a damaged roller for regime 2.

In the spectrum of the resonance zone there become apparent side combinational spectrum components with frequency interval changing proportionally to the frequency of rotor spinning (Table 4). Under such conditions, the ratio $\Delta f/2BSF$ is approximately equal to the ratio of angles on the right and on the left between the damage zones on the circumference of a roller $145^\circ/215^\circ = 0.67$.

All this indicates that relative peripheral position of damages on the surface of a roller can be determined by an interval between side combinational spectrum components in high-frequency resonance zones.

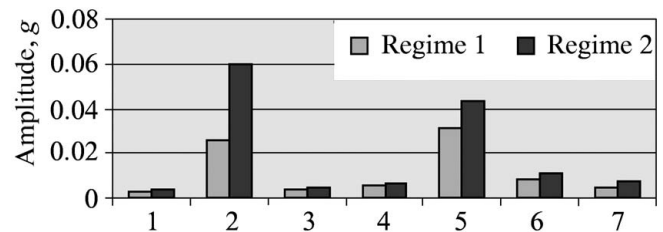
Fig. 7. Amplitudes of vibration acceleration in the frequency range 1.0...1.5 kHz:

- 1 – good state bearing; 2 – flattened surface along the whole length of a roller; 3 – short flattened surface on the part of the length of a roller; 4 – short groove on the part of the length of a roller; 5 – groove along the whole length of a roller; 6 – three sharp dent + one sharp dent; 7 – one sharp dent

- there is a significant difference between the signals of a good state bearing and those of the bearing with types of damages like long flattened surface on the part of the roller length, or long groove on the part of the roller length and three sharp dents + one sharp dent;
- there is an insignificant difference between the signals of a good state bearing and those of the bearing with types of damages like short flattened surface on the part of the roller length, or short groove on the part of the roller length and one sharp dent;
- increase of rotor spinning frequency increases the difference between signals of a good state bearing and a bearing with a damaged roller.

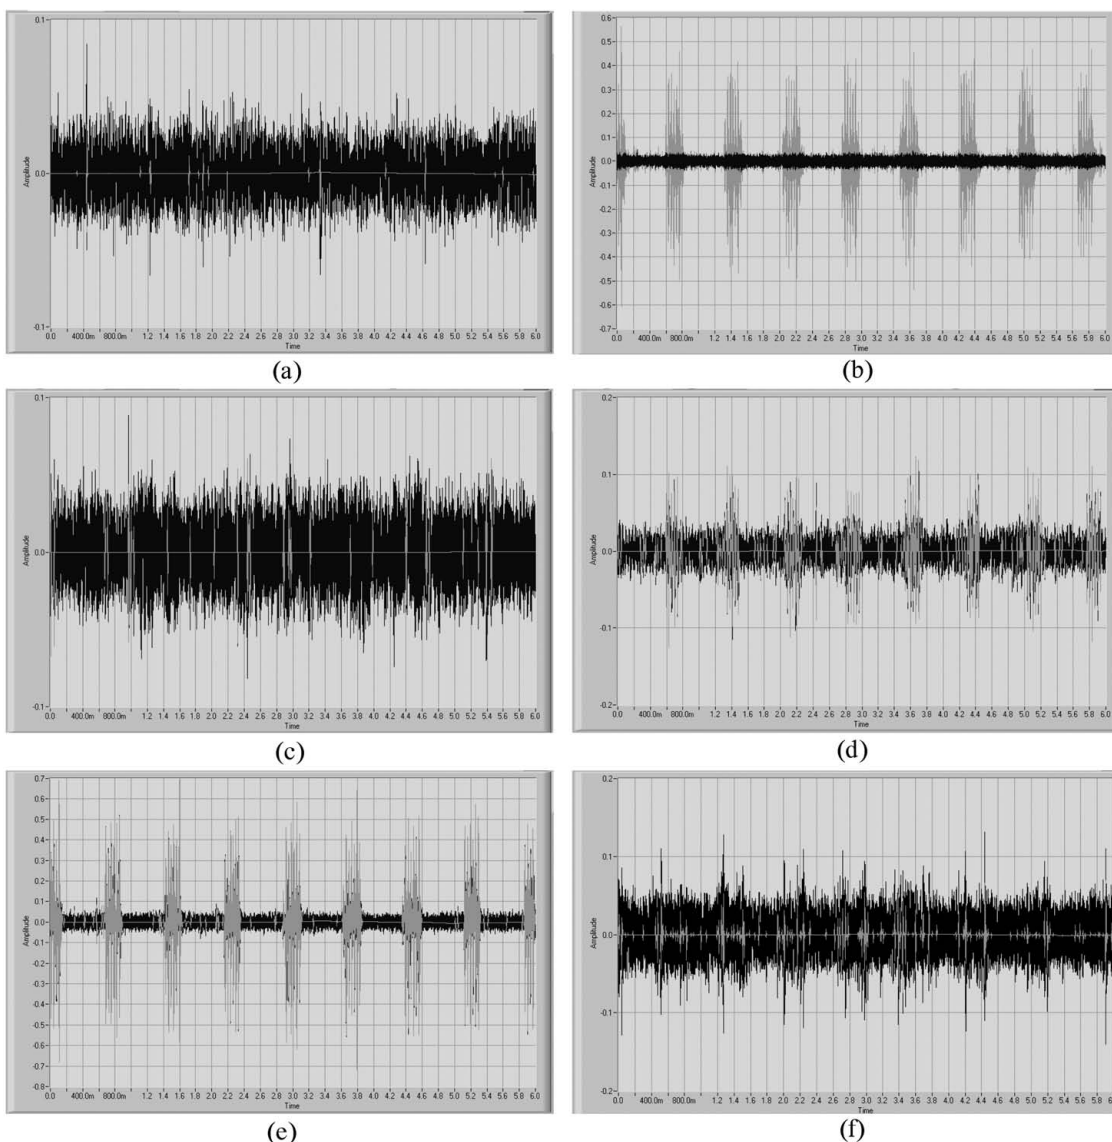
Fig. 8. Results of processing of a signal obtained during the testing of a variously damaged bearing:

The method of wavelet analysis [2] is effective in enhancing impulse components of signals with strong noise interference. As expected, wavelet analysis proved itself useful in detection of impacts from slight bearing damages, such as short grooves and little dents. Fig. 8 represents the results of processing of a signal obtained during the testing of a variously damaged bearing. According to recommendations of the work [3] there was applied wavelet transformation employing the Daubechies function of the type "db02". Parameters of the wavelet were automatically optimized. Impulse components of vibration signals obtained in process of wavelet filtering are shown in light color. It can be seen that the number and amplitude of signal impulses after wavelet transformation and even in case of slight roller damages are considerably larger, than from a good state bearing.

- (a) Without defects. (b) Flattened surface along the whole length. (c) Short flattened surface on the part of the length of a roller. (d) Short groove on the part of the length of a roller. (e) Groove along the whole length of a roller. (f) Three sharp dent + one sharp dent
