VIBRATION DIAGNOSTICS OF ANTIFRICTION BEARING DAMAGES DURING INSTALLATION AND ASSEMBLY OF HEAVY ROTORS

V.M. Shabaev, A.S. Kazantsev (JSC "Gasturboservice", Tyumen)
 M.K. Leontiev, I.V. Garanin (Moscow Aeronautical Institute, Moscow)
 V.A. Karasev (Central Institute of Aviation Motors (CIAM), Moscow)

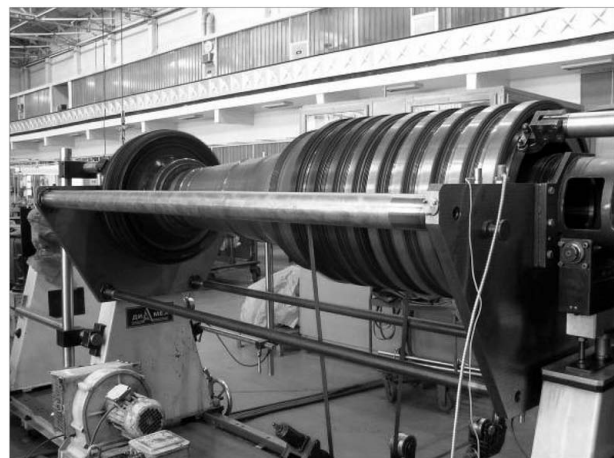
Fig. 1. General view of the rotor on a balanced stand from the side of the tested bearing. Also, there can be seen accelerometers on the stand cradle

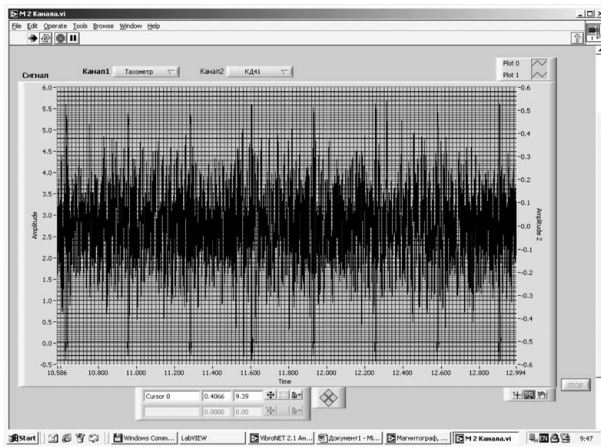
Fig. 3. Oscillogram of a good state bearing. Regime 1

Oscillograms of unfiltered signals from a good state bearing generally have noisy kind (Fig. 3).

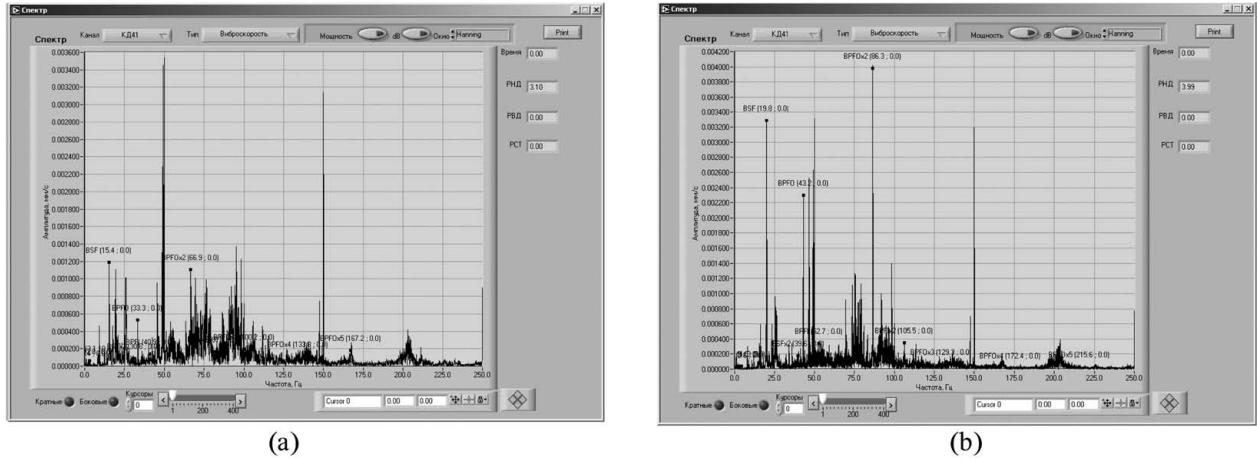
At the same time, the signals' spectra clearly show components with frequencies BSF, BPFO and their harmonic waves (Fig. 4).

Fig. 4. Spectrum of a good state bearing signal. (a) Regime 1. (b) Regime 2
